# Failure mechanism investigation of bottom plate in concrete box girder bridges

In the proposed study, the Linguo continuous rigid frame bridge was studied to determine the failure mechanisms by combining both field investigation and a 3D finite element (FE) method. The characteristics of the failure on the bottom plate were analysed and three typical failure models were identified. The failure mechanism was investigated and verified using a proposed 3D nonlinear FE model. Retrofit methods were proposed and implemented for the damaged bridges. The measured stress response and calculated stress response from the proposed 3D finite element model were compared. Satisfactory results were observed between field measurements and numerical simulations. Parametric studies were performed using the developed model to investigate several important parameters for the bridge design and construction. Finally, conclusions and recommendations for future bridge analysis and design were provided on the basis of the proposed study.

The field observation of bottom plate failure is from the Linguo Bridge. The Linguo Bridge is a long-span continuous rigid frame bridge across the Gunong River with a m

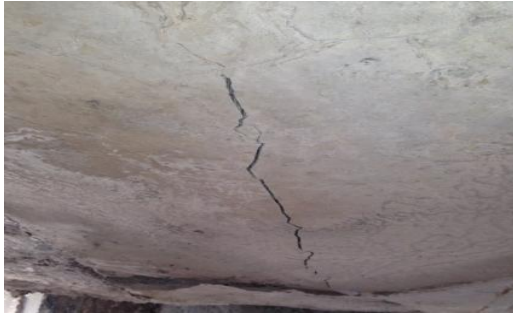
(a) Longitudinal cracks along the span direction

The main crack was longitudinal along the span direction (Figure 2). Many crushed zones on the bottom plate were distributed along the main crack. Additionally, irregular

form of waterlogging was formed. Large amount of concrete was lost when hammered slightly.

As shown in Figure 2, longitudinal cracks in the box girder with wide bottom plate were evident. The transverse deflection of the bottom plate was analysed as the horizontal frame structure under the radial uniform load, and the bottom can be simplified as a beam with both ends fixed, as shown Figure 5b.

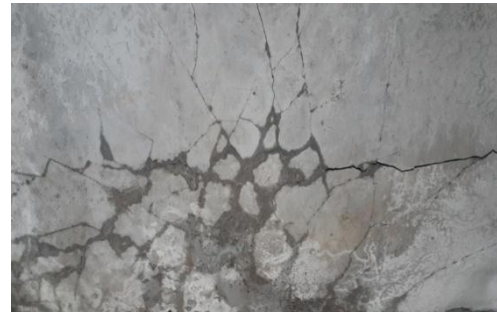
(b) Crushed zone on the bottom plate

cracking and punching shear failure caused by the prestressed strands, and the bottom plate would be split into upper and lower layers along the positions of the longitudinal corrugated pipes. In addition, under the action of the longitudinal (in  $y$  direction) stress, the splitting bottom plate would show buckling instability, and extreme displacement and deformation often occurred together (Figure 12b). Furthermore, the concrete split in the lower layer of the bottom plate along the longitudinal prestressed strands would be crushed (Figure 2b).

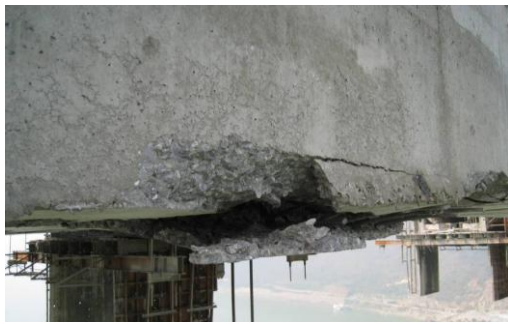
(a) Collapse of the bottom plate

Figure 3 shows that the concrete of the bottom plate was damaged, and the concrete cover was peeled off from the bottom plate at the connection of the web and the bottom plate. The covered concrete was removed, and the distribution and connection of the reinforcing bar in the concrete were explored. In this region, the concrete and reinforcing bar were separated, and no bond was found between the transversal and longitudinal reinforcing bar. In addition, no bond was detected at the connection of the longitudinal reinforcing bar.

As indicated in Figure 3, the concrete located at the corner of the box section was collapsed, where the thickness of the concrete cover was thin, and the reinforcing bar was not present. Under the action of the prestressed strand, the mechanism model of punching shear failure can be simplified as shown in Figure 6b.

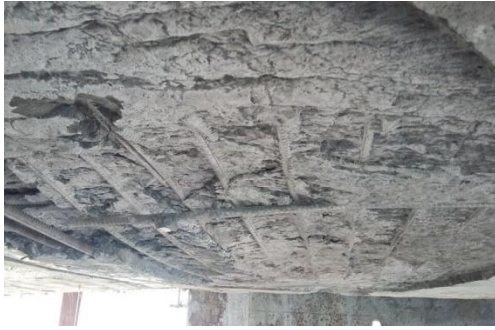
(a) Deformation of the reinforcing bar

Figure 4 shows that the bottom plate was deformed and the large deformation in the reinforced concrete was always accompanied with cracking. Corrugated pipes were found to be deflected significantly (Figure 4b). The bottom plate was split by the huge prestressed action.

The bottom plate indicated in this study shows that the cohesive strength was determined by the effect of the vertical reinforcing bar, axial tensile design strength and effective area of concrete. **Figure 4** shows that effective vertical reinforcing bar was rarely found between the corrugated pipes. Additionally, the effective area for resistance tension was found to be very limited because the corrugated pipes occupied large areas (**Figure 7**). The bottom plate was split into upper and lower layers under the radial load caused by the prestressing.

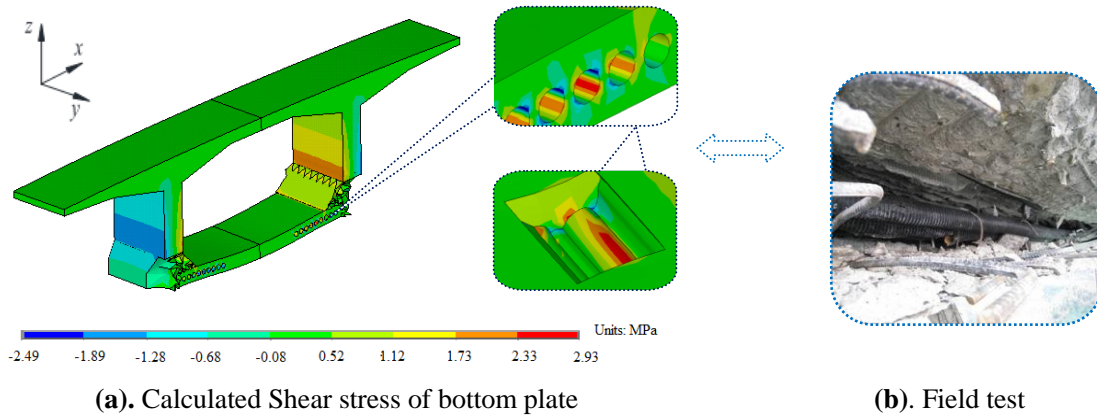
**Figure 11:** Calculated shear stress and field test failure of the bottom plate.

Figure 11a shows that shear stress varied from  $-2.49$  to  $2.93$  MPa, with the maximum value at the bottom plate distributed around the corrugated pipes. The shear strength was 2.52 MPa according to the design code JTG D62-2004. Obviously, a punching shear failure occurred, which was also observed at the corner of the box section, as shown in Figure 11b. A further comparison of Figure 11a and b shows that the calculated results are in agreement with the field observations for the punching shear failure mechanism (Figure 6).

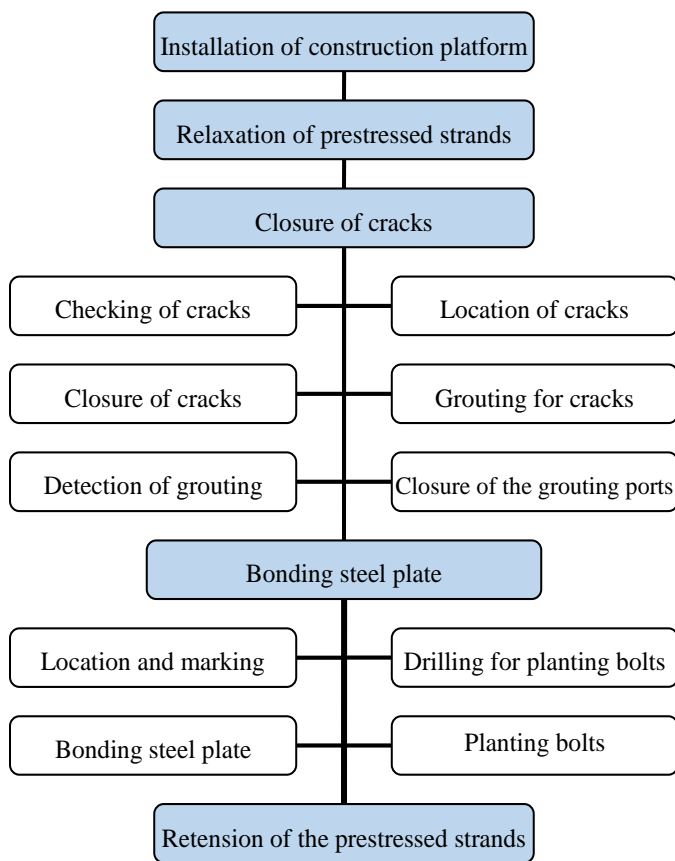
**Figure 13:** Procedure of reinforcement.

The deficiency shown in Figures 2 to 4 shows that the cracks would be closed, fractural steel bars would be welded and the concrete of punching shear and splitting failure would be reinforced. The reinforcement process is presented in Figure 13.

Figure 13 shows the seven basic steps applying the reinforcement of bonding steel plate as follows: relaxation of prestressed strands, closure of cracks, planting of bolts, bonding steel plate, repairing of bottom plate concrete and retension of the prestressed strands. The relaxation of the prestressed strands was symmetrically schemed from BP9 to BP1, as shown in Figure 14.

The cracks distributed on the bottom plate should be closed to meet the durability of the concrete structure. In this phase, the number, length and distribution of the cracks were investigated, which are important references for the scheme of grouting. The cracks should be cleansed and dried prior to grouting. Single grouting or multi-grouting depends on the size and region of the crack. Grouting pressure is set to be 0.2 MPa.

The bonding of steel plate is one of the most important steps during reinforcement. This step includes the location, marking and drilling for planting bolts to prepare the bonding of the steel plate. The location for drilling should be accurate, and the destruction of the prestressed corrugated pipe should be avoided. The final step involved the retension of the prestressed strands. The process and tension grade should be strictly decided in accordance with the requirements of the design. The deformation and stress of the beam should also be monitored.
